# OPERATION DESERT STORM

## Casualties Caused by Improper Handling of Unexploded U.S. Submunitions

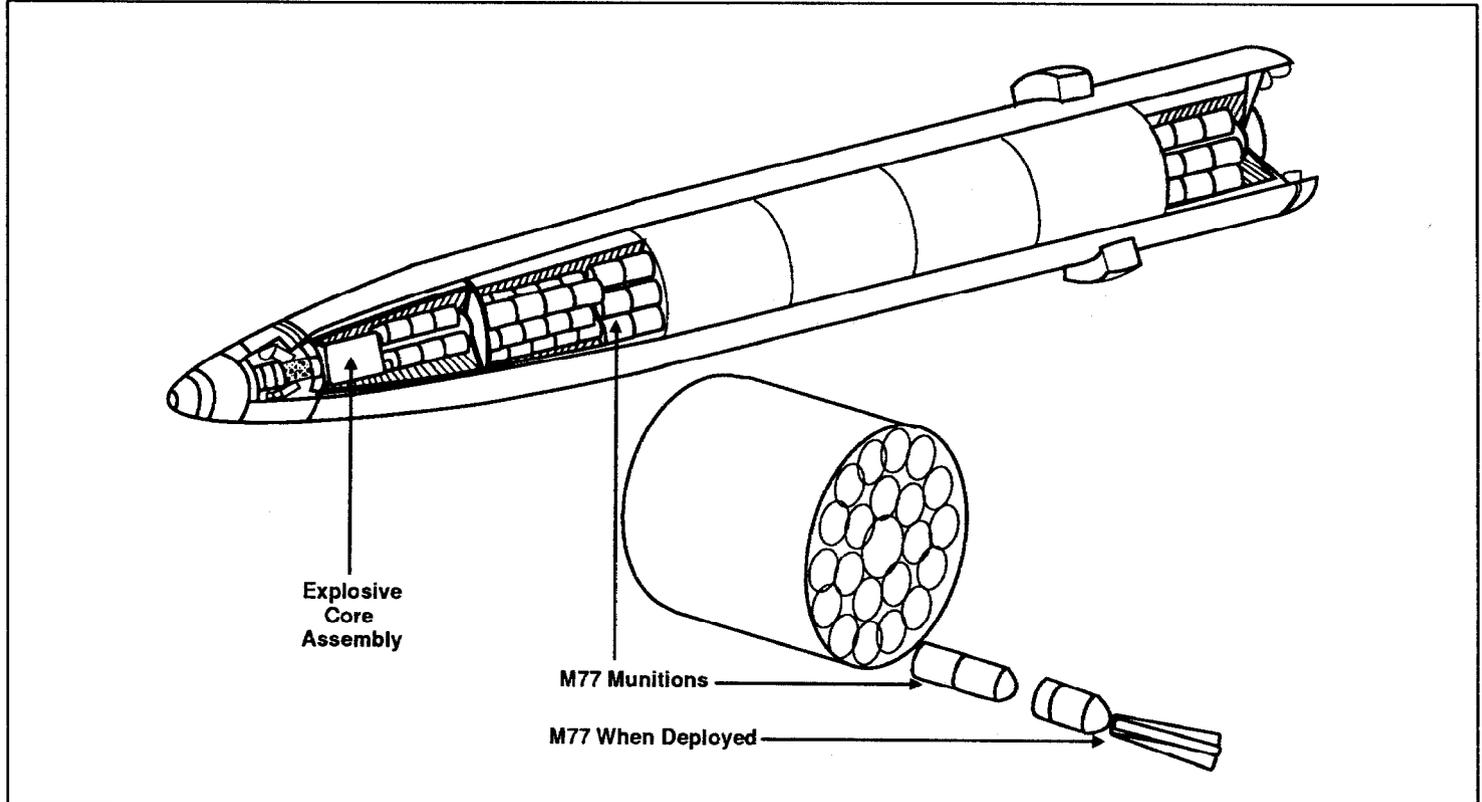
**Figure 1: MLRS Warhead Assembly With M77 Submunitions**

At a preset time, the artillery round or rocket explodes, expelling the submunitions over a target area. The submunitions are expected to explode upon impact. Figure 1 shows how M77 submunitions are packed into the MLRS warhead assembly.

Source: Armament, Munitions, and Chemical Command.

M42, M46, and M77 submunitions are small, cylindrically shaped explosive devices with a bell-like top. A looped ribbon is attached to each device to provide stabilization. Army weapon systems using these submunitions during Operation Desert Storm were the Multiple Launch Rocket System
